Nickel Hydrogen Cell Positive-Electrode Studies: Cobalt Segregation in Reducing Environments

A. H. ZIMMERMAN Laboratory Operations The Aerospace Corporation El Segundo, CA 90245-4691

22 May 1987

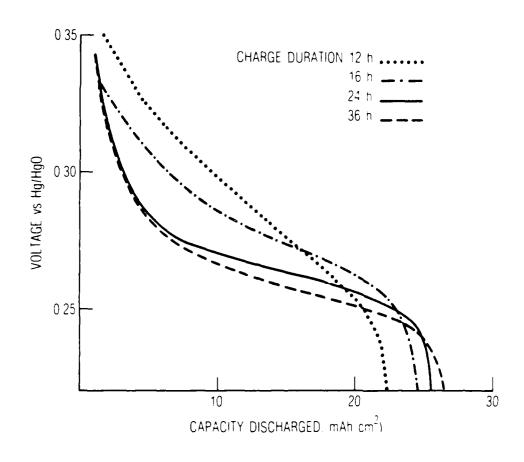
The discharge voltages in Figs. 1 and 2 clearly show a two-step discharge behavior that has been associated with discharge of β -NiOOH that is formed initially during charge, followed by discharge of γ -NiOOH at somewhat lower voltages (Ref.1). The γ -NiOOH phase is formed during overcharge, and can lead to a significantly higher discharge capacity following extended overcharge. The S/N 114 samples appear to form the γ -NiOOH phase much more readily than do the Lot 1008 samples. Furthermore, the S/N 114 electrodes appear to discharge at voltages that are significantly higher than the Lot 1008 electrodes for both the β - and γ -NiOOH phases. This suggests that all of the active material in the S/N 114 electrodes has somehow been altered to have a higher characteristic voltage. The charge voltages for 36 h of a C/1O charge are indicated in Fig. 3 for the two kinds of electrodes. Again, the charge voltages clearly show a higher characteristic voltage for the S/N 114

Fig. 1. Lot 1008 Ni Electrode Discharge (C/10) Following C/10 Charge

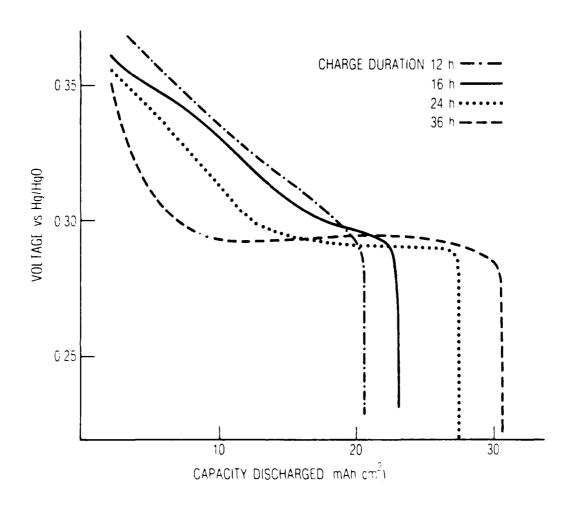
Fig. 2. S/N 114 Ni Electrode Discharge (C/10) Following C/10 Charge

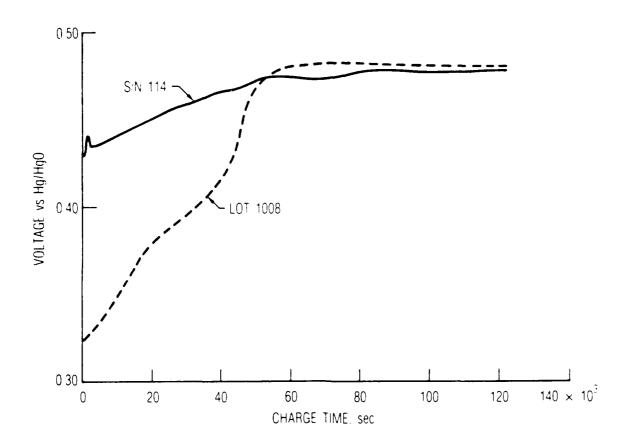
Fig. 3. Charge Voltage at C/10 for Ni Electrodes

electrode. Since Fig. 3 indicates that the oxygen evolution voltages of the two electrodes are not widely different, it is expected that the S/N 114 electrode that is charging at the higher voltage is likely to begin to generate oxygen sooner during charge than does the Lot 1008 electrode. This should result in a lower charge efficiency for the S/N 114 electrode for the first 10 to 14 h of the charge period. Table I indicates the capacities discharged at the C/10 rate for differing charge times. Since residual capacities were similar for all the charge times for a given electrode, the results of Table I confirm that the charge efficiency for the first 10 to 14 h of C/10 charging is lower for the S/N 114 electrode.

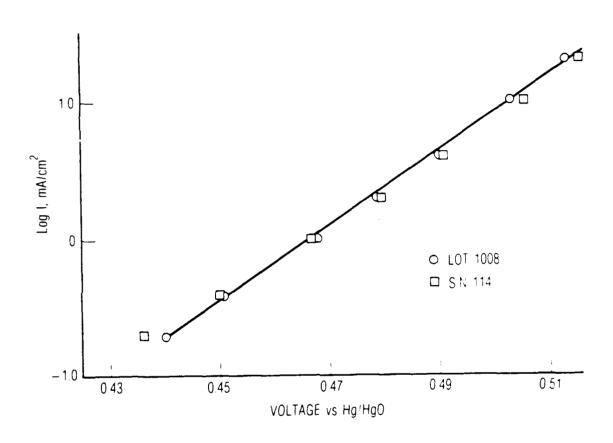
The I/V characteristics for the electrodes were measured in the overcharge or oxygen evolution region following a 36-h charge period at a C/10 rate. These measurements involved varying the overcharge current in steps, going from C/100 up to C/2. The electrode was allowed to remain at each current until a stable voltage reading was obtained (less than 0.1 mV change in 5 min). The measured I/V characteristics are presented in Fig. 4 for the two electrodes. The results in Fig.4 have been corrected for IR (voltage) drop in the solution between the nickel electrode and the reference electrode, which was determined by measuring the instantaneous voltage response to a small current step. The two kinds of electrodes in Fig. 4 do not show large differences in their I/V characteristics for oxygen evolution.

Fig. 4. I/V Behavior During Steady-State Oxygen Evolution for Ni Electrodes

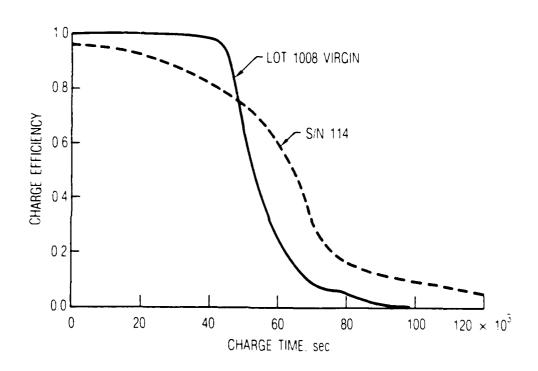
The charge efficiencies that were calculated are indicated in Fig. 5, and clearly show the lower charge efficiency for the S/N 114 electrode during the early portion of the charge period. The tailing off of the charge efficiency at long charge times is likely to be due to charging to the \gamma-NiOOH phase, a process that is known to have a low efficiency (Ref.1), particularly at charge rates as low as C/10. Several reasons may account for the lower charge efficiency of the S/N 114 electrodes. First, the cycling that these electrodes have experienced in the nickel hydrogen cell can degrade charge efficiency somewhat. The charge efficiency differences indicated in Table I and Fig. 5 for the two electrode types appear to be more than can be accounted for by normal performance changes arising from a moderate number of charge/discharge cycles, although this is likely to be a contributing factor. The second factor is the process that has caused the unusual increase in characteristic discharge voltage, which has, by raising the charge voltage, also decreased charge efficiency.

Fig. 5. Change Efficiencies Calculated Using Eq. (1) for the C/10 Charge Profiles of Fig. 3

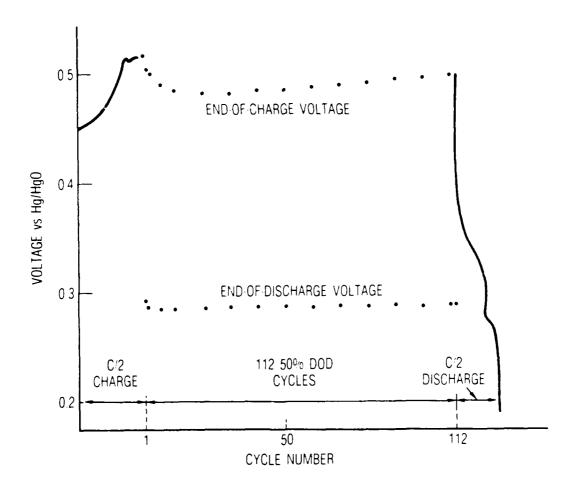
The behavior of the S/N 114 electrodes during cycling was of interest, since extensive cycling of cells reportedly improved the cell capacity characteristics. An electrode sample from S/N 114 was subjected to 112 cycles, each cycle lasting 90 min and having approximately a 50% DOD at the C/2 rate. Charge return on each cycle was 104% of the capacity discharged, and a C/2 charge rate was used. The voltage characteristics during these cycles are indicated in Fig. 6. The largest voltage changes during the cycling are an initial drop followed by a gradual increase in the end-of-charge voltage. The cycling was found to have little effect on the high-discharge voltage characteristics or the degraded capacity characteristics (for a 16-h charge) for the S/N 114 electrode.

Fig. 6. Voltage During 112-Cycle Test of S/N 114 Ni Electrode

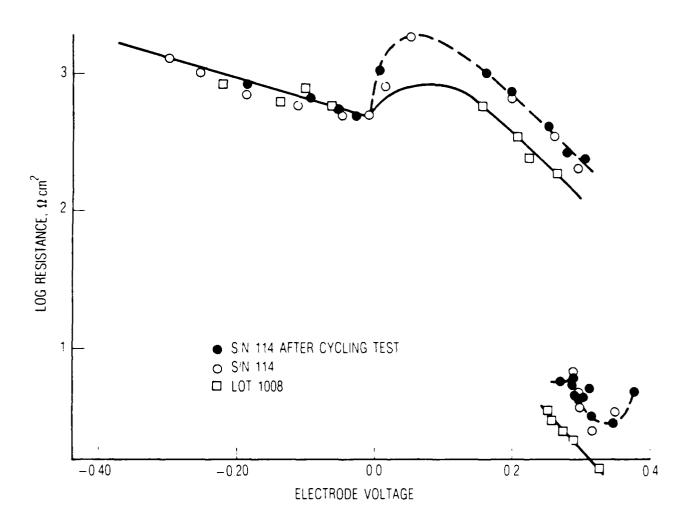
The electrode resistance, which is the low frequency limit approached by the impedance, is plotted as a function of electrode voltage in Fig. 7 for the Lot 1008 electrode, and for the S/N 114 electrode both before and after the 112-rvcle test previously described. The principal difference in resistance between the two types of electrodes is again the offset in voltage seen in Fig. 7. This kind of voltage offset is similar to the effects reported in Ref. 3 that are caused by the addition of 5% cobalt or lithium to the nickel electrode. This observation, which is consistent with the previous observation of a higher discharge and charge voltage for the S/N 114 electrodes, suggested that detailed analyses for additives and/or contaminants should be performed.

Fig. 7. Nickel Electrode Resistance During Discharge

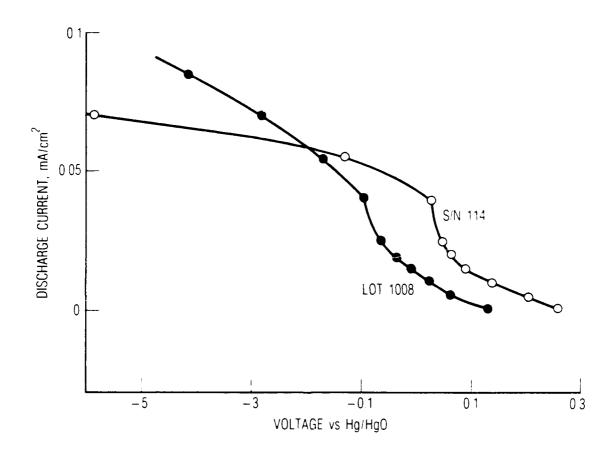
A final electrical test involved measuring the I/V characteristics of the active material in the discharged state. This was done by discharging electrode samples to -0.5 V at a C/100 rate, after which the electrode was held at a constant voltage until a steady current was obtained. The I/V behavior thus obtained is indicated in Fig. 8. The I/V behavior indicated is not simple, and also is relatively similar for both types of electrodes except for a voltage offset. The behavior at currents above 0.04 mA/cm² results because the electrode state of charge was being depleted significantly during the measurement and the active material developed internal polarization from this process. While the S/N 114 electrodes appeared to have somewhat more residual capacity (probably from surface material that was not in close proximity to the current collector), this did not appear to be a major factor in the total capacity of these electrodes.

Fig. 8. I/V Characteristics of Discharged Ni Electrodes

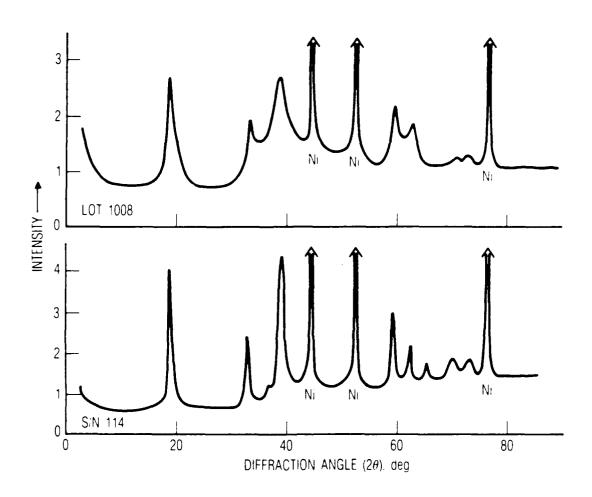
The structure of the active materials within the sintered electrodes was analyzed by x-ray diffraction studies of the powder obtained by grinding electrode samples at various states of charge after rinsing out the electrolyte and drying in vacuum. Figure 9 indicates the x-ray patterns obtained for the discharged electrodes. The patterns in Fig. 9 show the same peaks for both types of electrodes, a pattern that corresponds to nickel hydroxide. The Lot 1008 electrode has much broader peaks that are slightly shifted in position from the S/N 114 peaks. The lattice parameters for the active material are calculated from the peak positions, and are indicated in Table III for the two types of active material as well as for pure nickel hydroxide (Ref.5). Note that the peaks that go off scale in Fig.9 are due to the nickel metal in the powdered sinter.

Fig. 9. X-Ray Diffraction Pattern for Discharged Electrodes

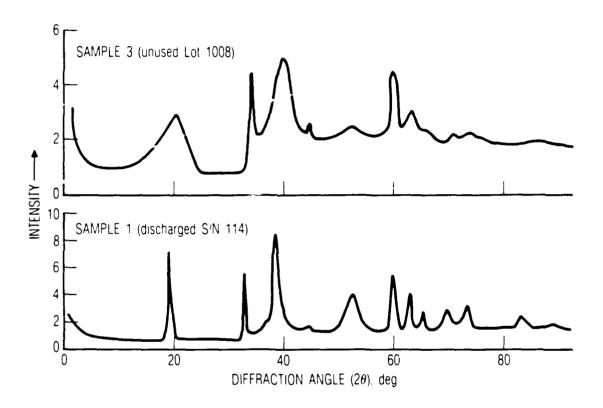
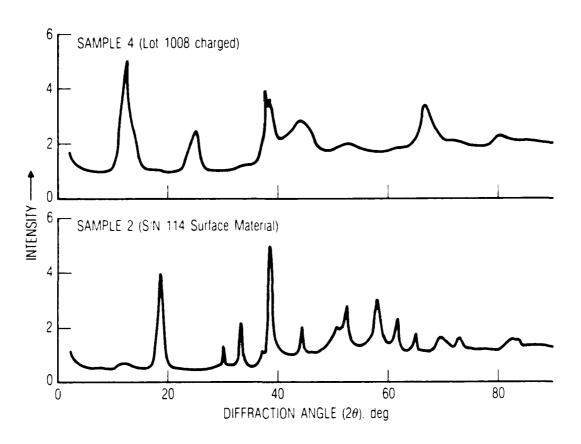
X-ray diffraction measurements of the four powder samples gave the results indicated in Figs. 10 and 11. These x-ray diffraction results for the active materials are for the most part similar to those previously obtained for the electrodes during the electrode characterization testing, except that the peaks due to nickel metal have been eliminated. Sample 1 shows the x-ray pattern for nickel hydroxide. Sample 2 is a mixture of the nickel hydroxide and a small amount of γ -NiOOH. Sample 2 also contains significant quantities of zircar fibers, as indicated by the peak at about 30 deg. Sample 3 has the nickel hydroxide structure; however, it is quite disordered as indicated by the broad peaks. Sample 4, although having somewhat broadened peaks, basically shows the γ -NiOOH structure that is characteristic of fully charged active material.

Fig. 10. X-Ray Diffraction Patterns for Ni Active Material Samples from Electrodes Prior to Electrical Activity

Fig. 11. X-Ray Diffraction Patterns for Ni Active Material Samples Prepared by Charging.

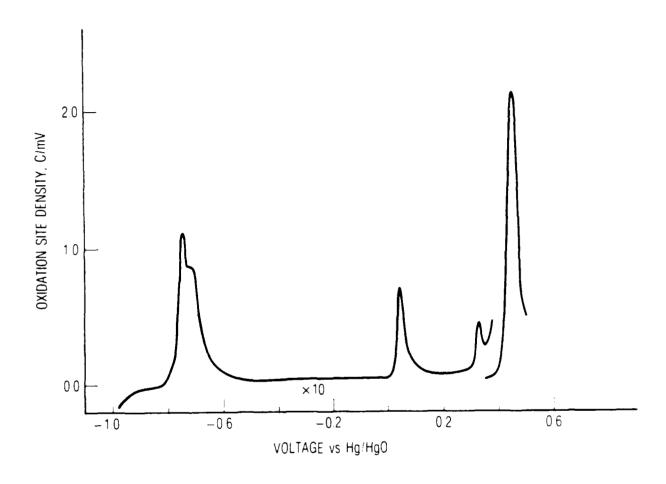
The Lot 1008 electrode that was reversed for 2 months was run through an EVS scan from the hydrogen evolution region (about -1.0 V) up to 0.5 V, where it is in a nearly fully charged state. A sweep rate of 0.01 mV/sec was used. The results are indicated in Fig. 12. Figure 12 does indeed show several of the reactions of interest. A double peak between -0.8 and -0.7 V is consistent with oxidation of cobalt and nickel metal per reactions (2) and (3). The peak at about 0.05 V is consistent with oxidation of cobalt hydroxide to trivalent cobalt. Thus the scan in Fig.12 is consistent with the model outlined above for cobalt segregation.

Fig. 12. EVS Scan of Lot 1008 Electrode Reversed for 2 Months at C/40. Scan is from initial rest voltage to 0.5 V, at 0.02 mV/sec.

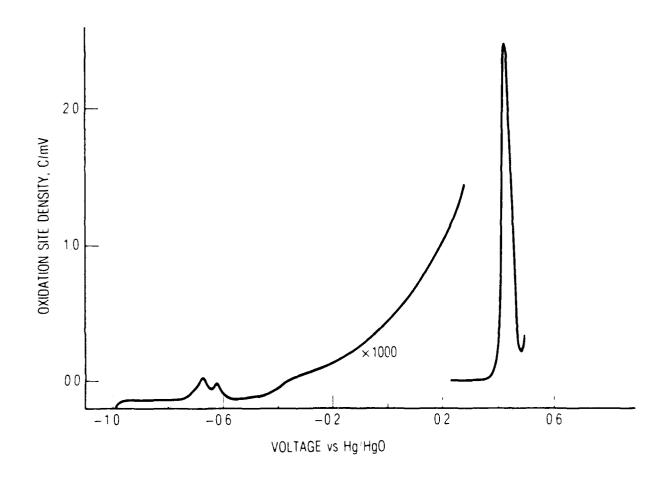
Several tests were done to study factors that may influence the rate at which cobalt segregation reactions can occur. The first of these started with an uncycled Lot 1008 electrode sample. This electrode was dipped several times in a suspension of platinum black in acetone in an attempt to put platinum into the active material. After drying, the electrode was reversed at C/10 for 5 days, after which an EVS scan was done. The results are shown in Fig. 13. Only two small peaks are present at lower potentials in Fig. 13.

Fig. 13. EVS Scan for Lot 1008 Electrode Reversed for 5 Days at c/10, after Dipping in Pt Suspension. Scan is from rest potential to 0.5 V, at 0.01 mV/sec.

These results suggest that essentially no cobalt segregation took place over this 5-day period. Since it is not clear that the platinum was in intimate contact with much of the active material, the interpretation of these results is somewhat uncertain.

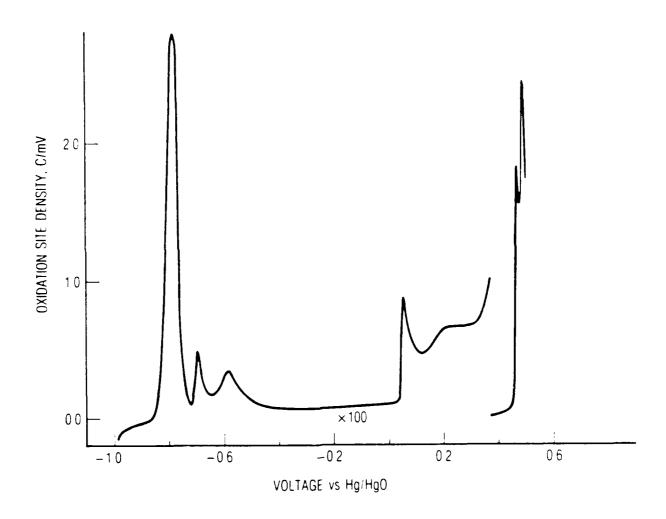
A similar test used a piece of S/N 114 electrode that had also been in reversal for 5 days at C/10, providing the EVS results in Fig. 14. This scan shows a large peak due to nickel and cobalt metal oxidation (-0.8 V), two smaller peaks near -0.7 and -0.6 V that may be from the carbonate reactions (reactions 4 and 5), and a large peak at 0.05 V corresponding to formation of trivalent cobalt. These results indicate that, in the S/N 114 electrodes, conditions are such that cobalt segregation reactions can occur much more rapidly than for Lot 1008 electrodes. These tests do not answer the question of how much platinum accelerates the rate of cobalt segregation, since for S/N 114 electrodes that are known to have Pt in intimate contact with the active material, high reaction rates are observed. For Lot 1008, a low rate for the cobalt segregation reactions was observed, but the Pt may not have been adequately imbedded in the active material. Another possibility, explaining the differences in reaction rates implied by Figs. 13 and 14, is simply that the morphology and contact area with catalytic surfaces differ significantly for the two different types of electrodes.

Fig. 14. EVS Scan for S/N 114 Electrode Reversed for 5 Days at C/10.
